March 03, 2022
Building Health and Air Quality Assessment
ACS-22-119 Lakeside City Hall

The purpose of this assessment is to evaluate the general air quality and visually inspect suspected asbestos and lead materials for public safety concerns.

Facilities included are the main City Hall offices, the library and the senior center.

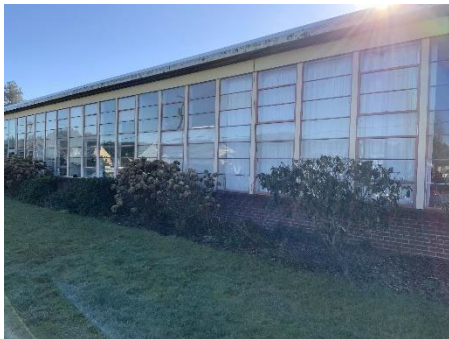
➤ Northern Wall:

- Brick, Metal Clad Doors, Vinyl Windows, Wood Trim, Wood Facia and Metal Gutters/Downspouts.

Condition: No Visible Mold or fungal growth. All building materials appear to be operable and in good condition.

Note: Observed the vegetation around the building is within 1 foot from the exterior walls. It is recommended that the landscaping be trimmed back to provide 2 feet of clear space.

1. Trim or remove vegetation around buildings to maintain a 2' clear space.
2. Moss removal and cleaning should be maintained on all buildings to mitigate possible damage that could cause moisture intrusion in the future.
3. Seal and repair areas of deteriorated paint. Test areas for lead-based paint prior to repairs in order to mitigate any safety concerns. It is recommended the city consult with a certified lead-based paint contractor to conduct the repairs.
4. Repair and seal the crack in the wall behind the door leading to the food pantry storage room.
5. Ensure that all heating systems are clean and vacuums being used have HEPA filtration along with a good maintenance schedule to maintain low dander levels.

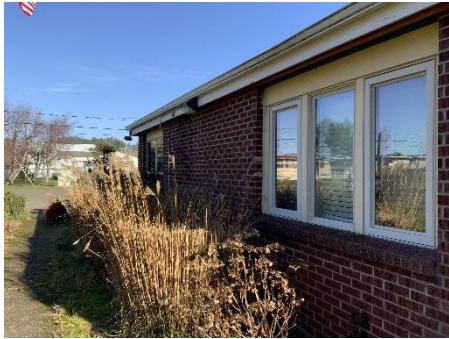
➤ Western Wall:

- Brick, Vinyl Windows, Wood Trim, Wood Facia and Metal Gutters/Downspouts.

Condition: No Visible Mold or fungal growth. All building materials appear to be operable and in good condition.

Note: Observed the vegetation around the building is within 1 foot from the exterior walls. It is recommended that the landscaping be trimmed back to provide 2 feet of clear space.

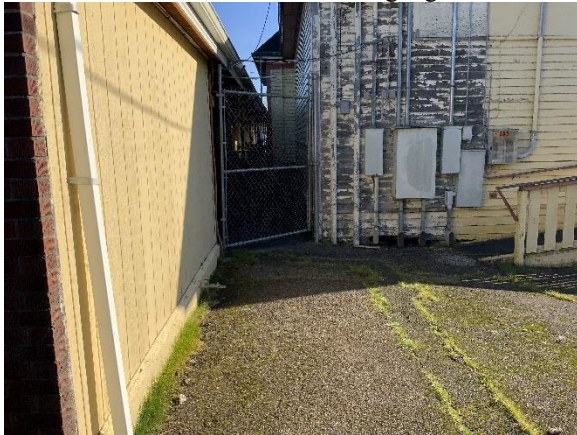
➤ **Southern Wall:**

- Wood lap siding, Metal Clad Doors, Vinyl Windows, Wood Trim, Wood Facia, Plywood Soffits and Metal Gutters/Downspouts.

Condition: No Visible Mold or fungal growth. All building materials appear to be operable and in good condition.

Note: Grass and moss had grown in the cracks of the walkways and between the walkway and foundation. It is recommended that these areas be cleaned and appropriately sealed to minimize facility damage.

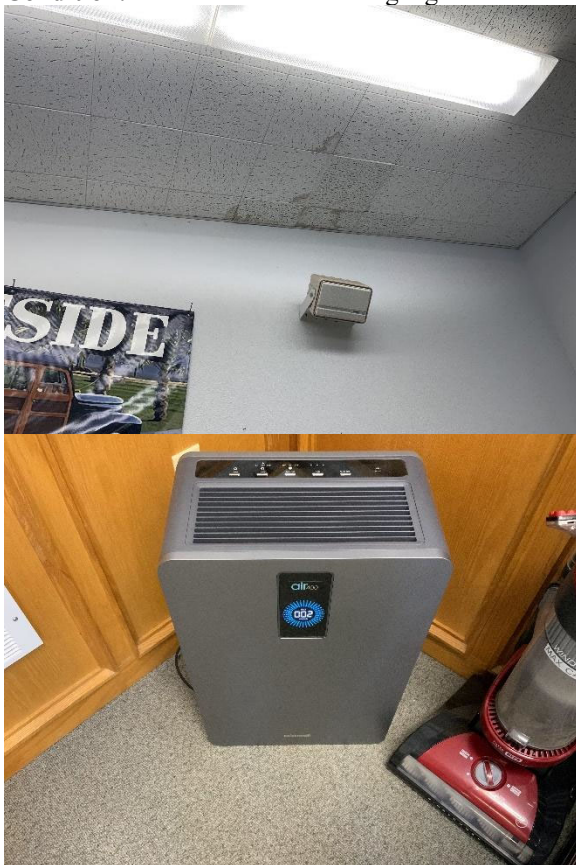
Note: Areas of discoloration were noted on the ceiling tiles from previous roof leaks. There is no evidence of any growth and no moisture detected at the time of inspection.

Note: Bissel Air filter in use in the main council chamber. AQI 002-005 during inspection

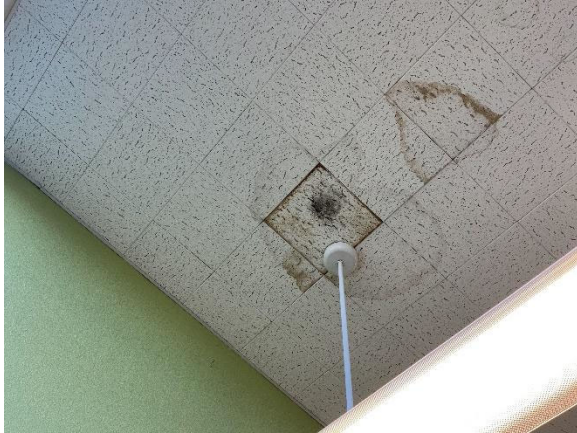
Note: Areas of discoloration were noted on the ceiling tiles from previous roof leaks. There is no evidence of any growth and no moisture detected at the time of inspection. This being the most discolored, it was removed to inspect underneath. No growth and only minor discoloration was noted behind the tile.

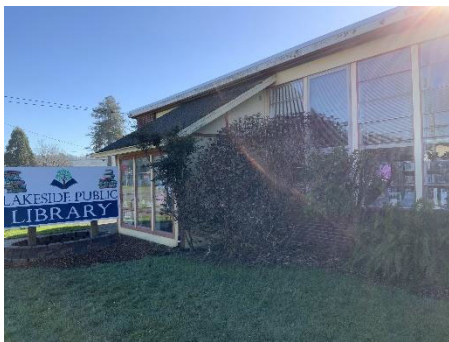
- Brick, Metal Clad Doors, Metal Clad windows, Vinyl Windows, Wood Trim, Wood Facia and Metal Gutters/Downspouts.

Condition: No Visible Mold or fungal growth. All building materials appear to be operable and in good condition

Note: Observed the vegetation around the building is within 1 foot from the exterior walls. It is recommended that the landscaping be trimmed back to provide 2 feet of clear space.

The facia appears to have surface discoloration. This could indicate moisture infiltration of the building material. ACS recommends the facia be cleaned and sealed/repainted to minimize any future damage.

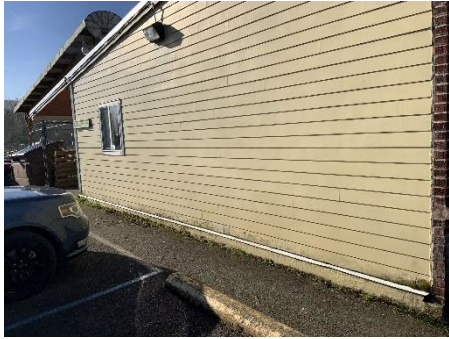
- Wood Lap Siding, Vinyl Windows, Wood Trim, Wood Facia and Metal Gutters/Downspouts.

Condition: No Visible Mold or fungal growth. All building materials appear to be operable and in good condition.

Note: Grass and moss had grown in the cracks of the walkways and between the walkway and foundation. Moss was also noted growing on the metal flashing at the base of the lap siding. It is recommended that these areas be cleaned and appropriately sealed to minimize facility damage.

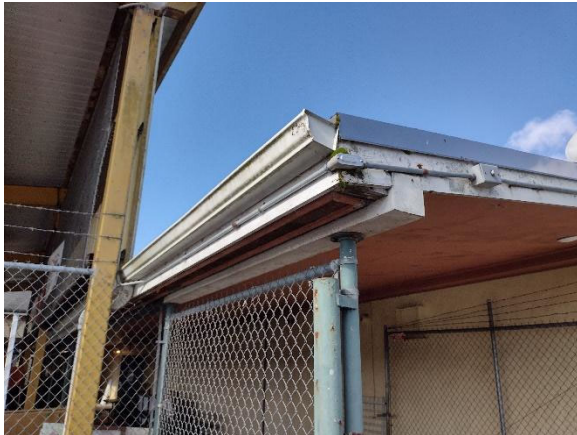
➤ **Southern Wall:**

- Wood lap siding, Metal Clad Doors, Wood Trim, Wood Facia, Plywood Soffits and Metal Gutters/Downspouts.

Condition: No Visible Mold or fungal growth. All building materials appear to be operable and in good condition.

Note: Moss was noted in the corners and around the gutters. It is recommended that these areas be cleaned and appropriately sealed to minimize facility damage.

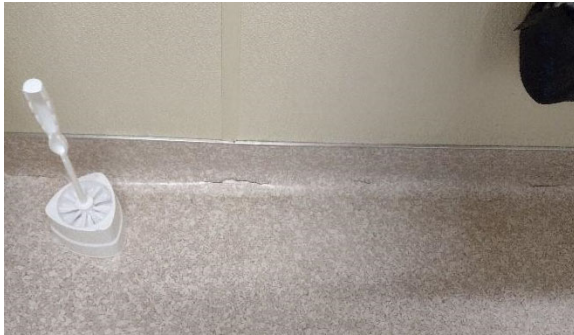
➤ Bathrooms:

- Ceilings/Walls:
 - PVC Paneling, Sheetrock with Joint Compound and Texture Walls
- Floor:
 - Concrete Slab, Sheet Vinyl
- Windows/Doors:
 - Vinyl Clad Windows, Metal Clad Exterior Windows
- Sinks and Counters:
 - Two bathrooms with standard commodes and sinks.
 - Standard Exhaust Fans

Condition: No Visible Mold or fungal growth. All building materials appear to be operable and in good condition.

Note: Cracks in the sheet vinyl flooring was noted. It is recommended the cracks are sealed to reduce moisture collection and future mold growth.

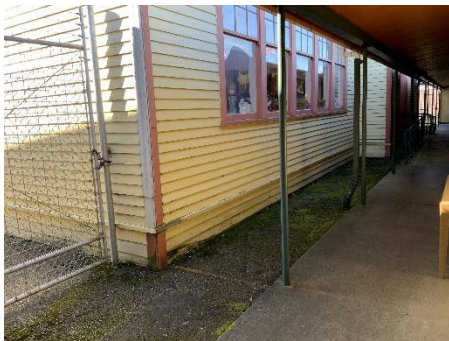
- Solid Core Wood Doors, Wood Windows, Wood Lap Siding, Wood Trim, Wood Facia and Metal Gutters/Downspouts.

Condition: No Visible Mold or fungal growth. All building materials appear to be operable.

Note: Moss was noted on the pavement and discoloration to the lower wood skirting at the northeast corner. This indicated increased moisture in this area. It is recommended that these areas be cleaned and appropriately sealed to minimize facility damage.

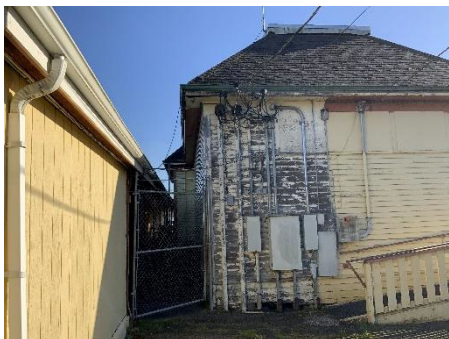
➤ Western Wall:

- Wood Lap Siding, Vinyl Windows, Wood Trim, Wood Facia and Metal Gutters/Downspouts.

Condition: No Visible Mold or fungal growth. All building materials appear to be operable and in good condition.

Note: Paint deterioration has been noted on the northwestern corner of the building. Based on the age of the building the exterior should be assessed or assumed to contain lead-based paint. ACS recommends a lead-based paint certified contractor be contacted to assess the damaged areas and encapsulate, remove or repair as required.

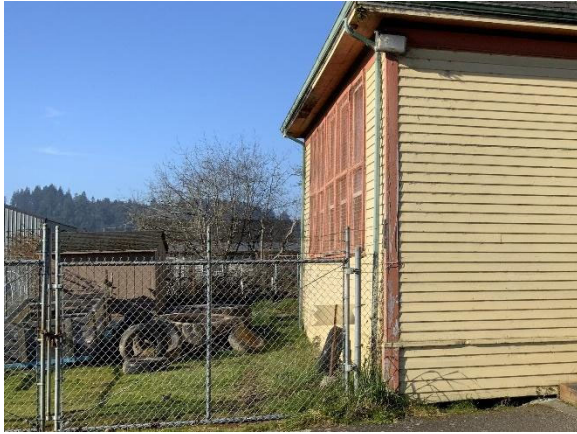
➤ **Southern Wall:**

- Wood Lap Siding, Wood Windows, Wood Trim, Wood Facia, Plywood Soffits and Metal Gutters/Downspouts.

Condition: No Visible Mold or fungal growth. All building materials appear to be operable and in good condition.

Note: Moss And discoloration was noted on the soffits, facia, and around the gutters. It is recommended that these areas be cleaned and appropriately sealed to minimize facility damage.

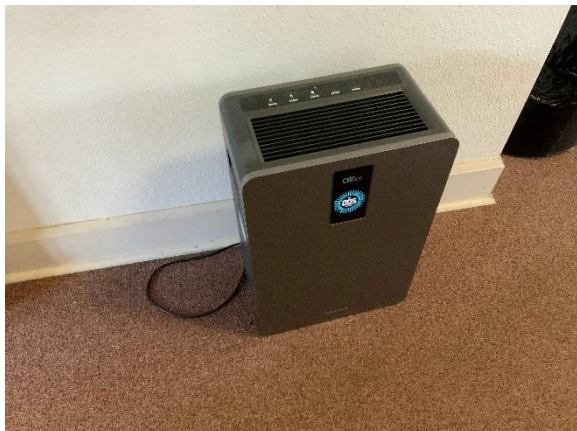
- Ceilings/Walls:
 - Lath and Plaster, Sheetrock with Joint Compound and Texture
- Floor:
 - Wood Floor, Carpet
- Windows/Doors:
 - Wood Windows, Solid Core Wood Exterior Doors

Condition: No Visible Mold or fungal growth. All building materials appear to be operable and in good condition.

Note: Bissell Air filter in use in the main council chamber. AQI 002-005 during inspection

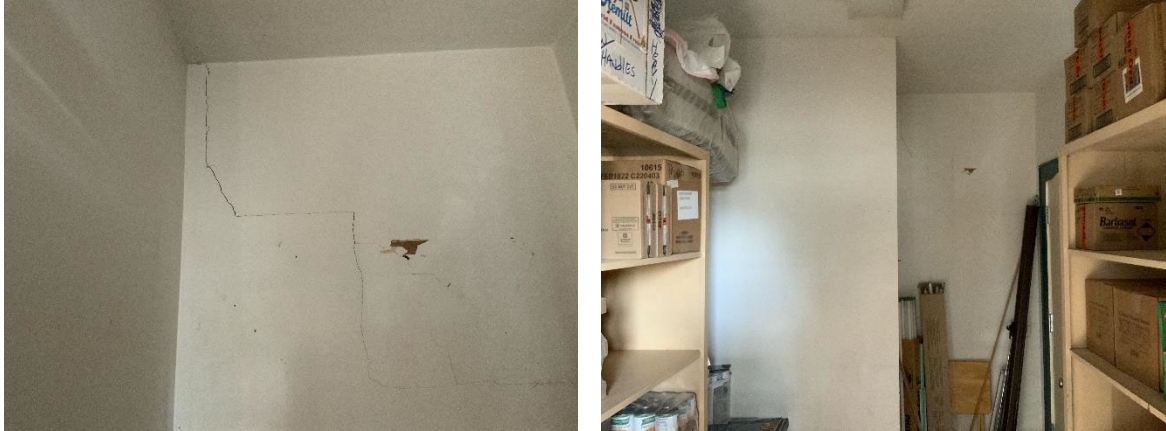
- Ceilings/Walls:
 - Lath and Plaster, Sheetrock with Joint Compound and Texture, Drop Ceiling with Pressboard Tiles.
- Floor:
 - Wood Floor
- Windows/Doors:
 - Wood Windows, Solid Core Wood Exterior Doors

Condition: No Visible Mold or fungal growth. All building materials appear to be operable and in good condition.

Note: There is a crack in the plaster wall of the storage room adjoining the pantry storage room. It is recommended the crack be filled and sealed to minimize any progressing damage.

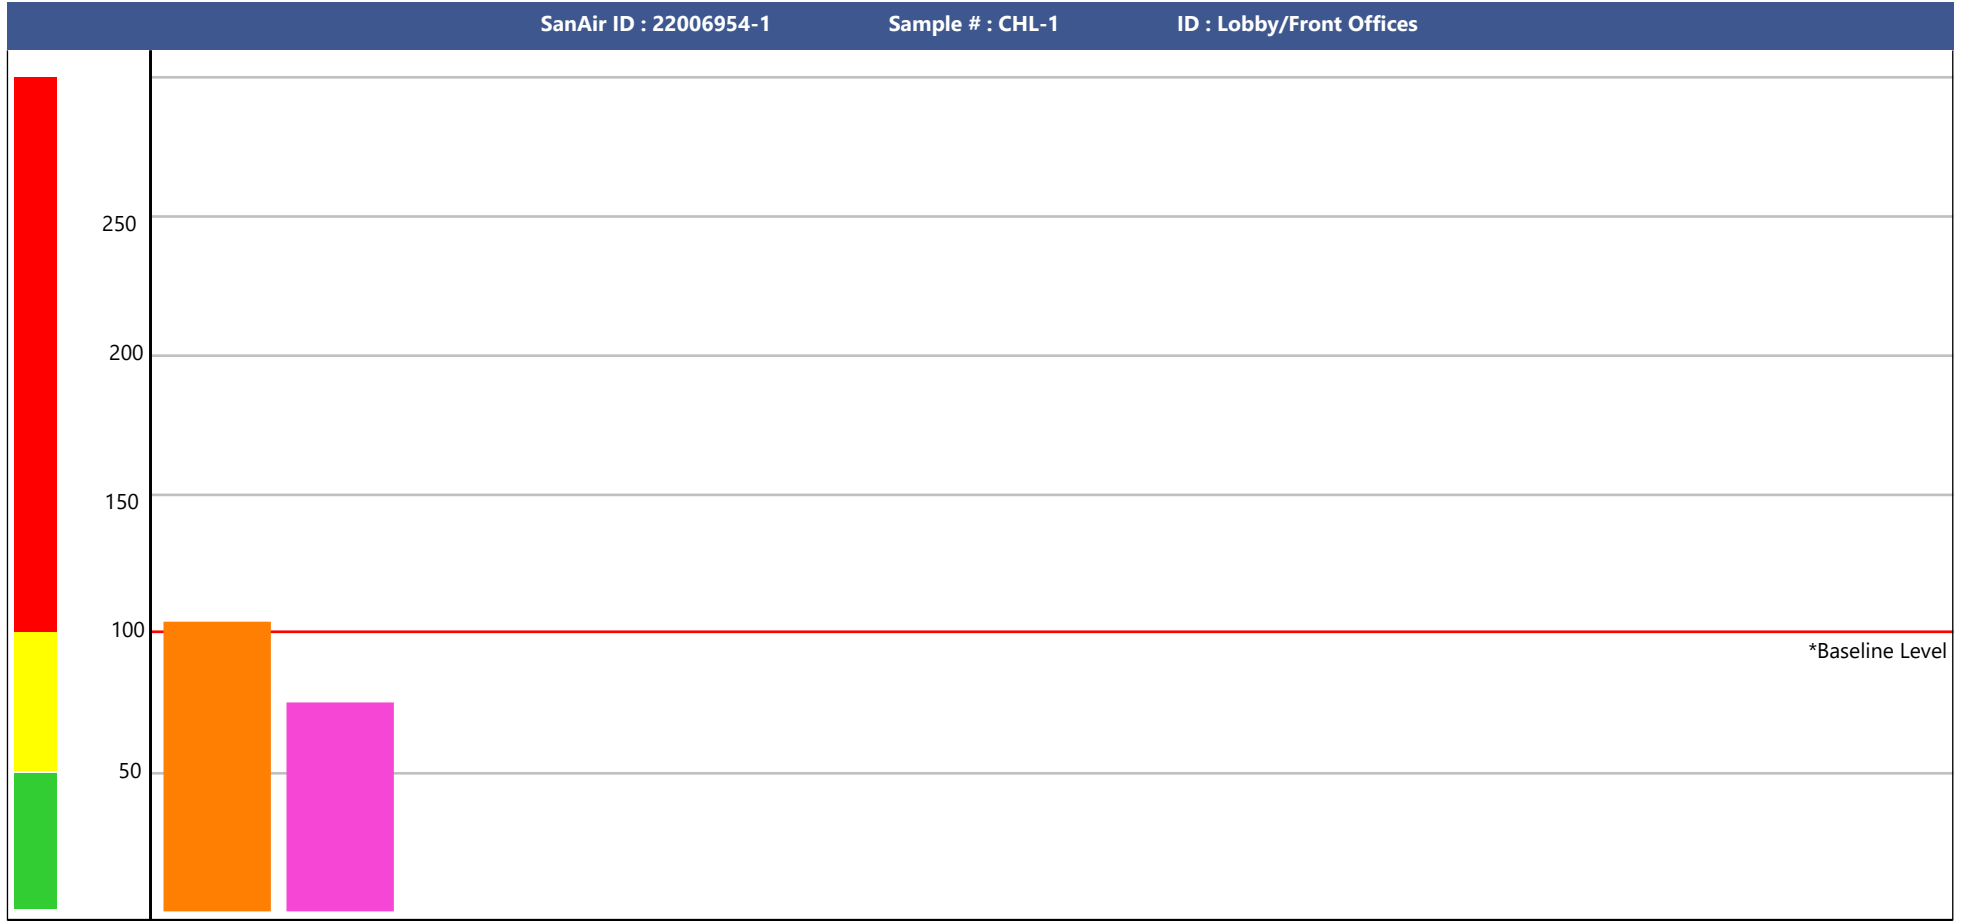
Air Cassette Analysis - Spores % of Outside Air

Count/m³ higher than Baseline	Aspergillus/Penicillium	Basidiospores
Count/m³ comparable to Baseline		
Within 50% of Baseline Count/m³

*The Baseline Level (100%) represents the average baseline sample counts. Counts above the baseline may indicate higher than expected levels of a given result.

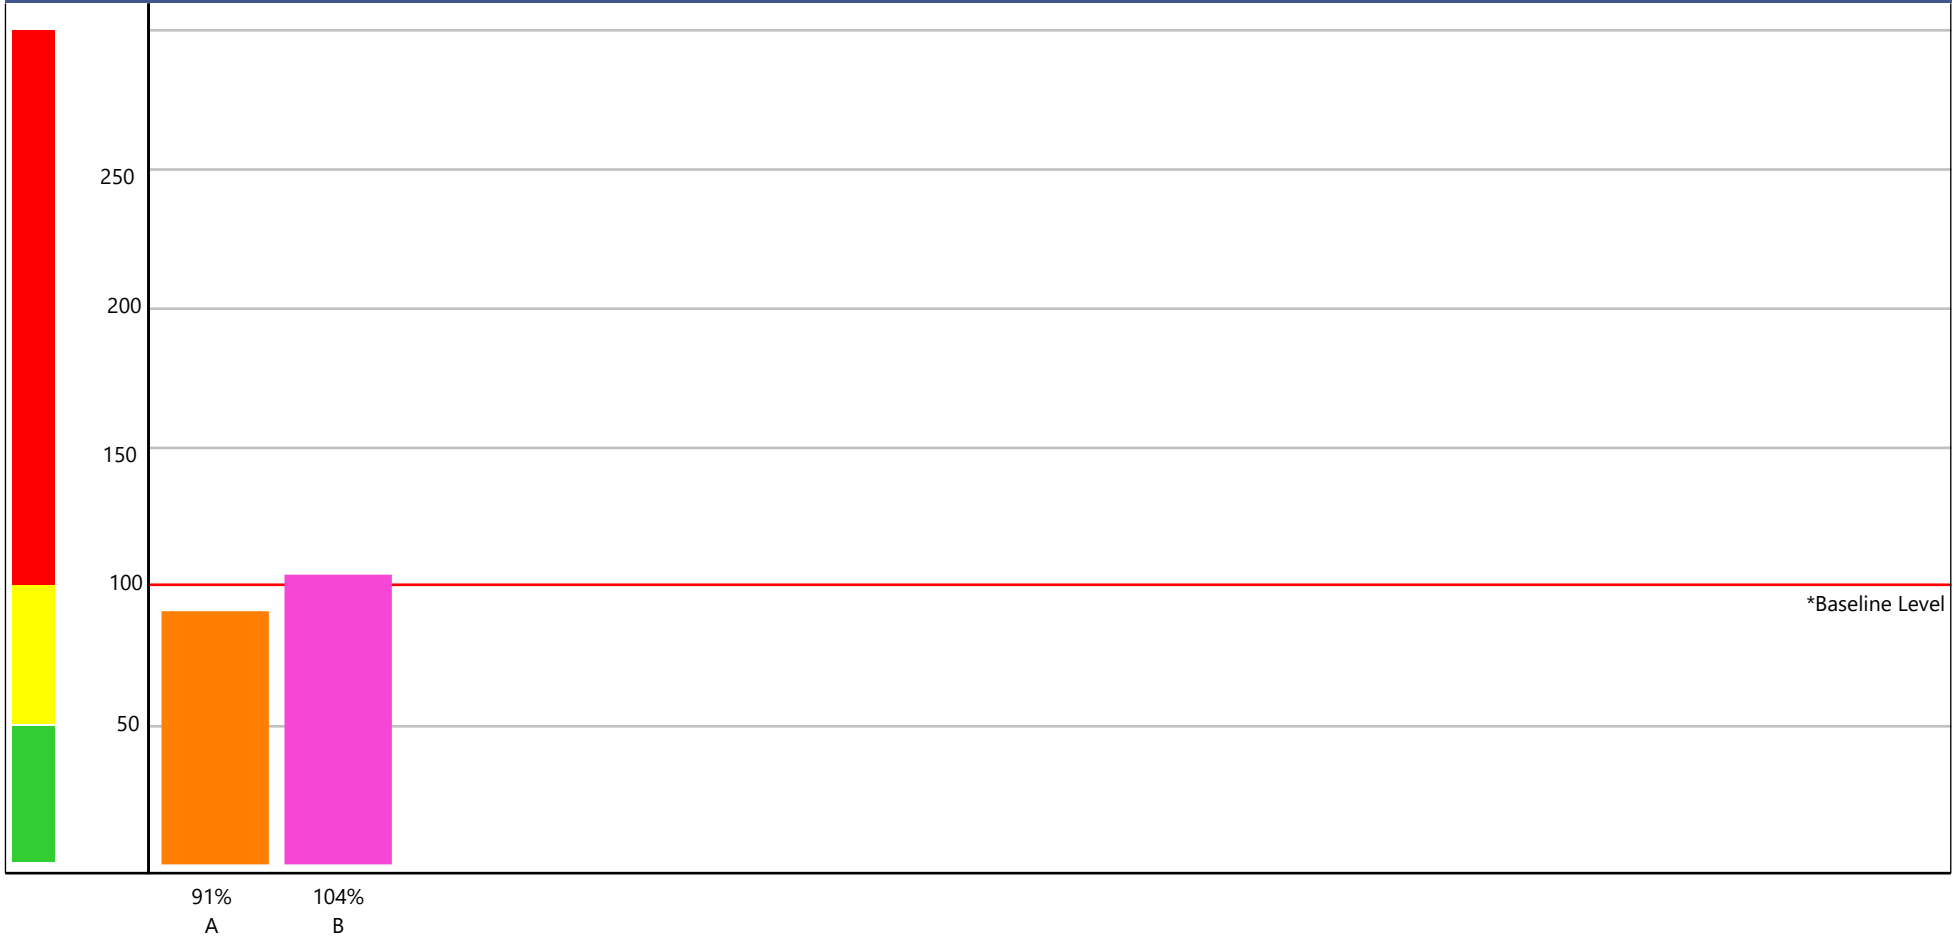
SanAir ID : 22006954-2 Sample # : CC-2 ID : Council Chambers

Count/m³ higher than Baseline	Aspergillus/Penicillium	Basidiospores
Count/m³ comparable to Baseline		
Within 50% of Baseline Count/m³

*The Baseline Level (100%) represents the average baseline sample counts. Counts above the baseline may indicate higher than expected levels of a given result.

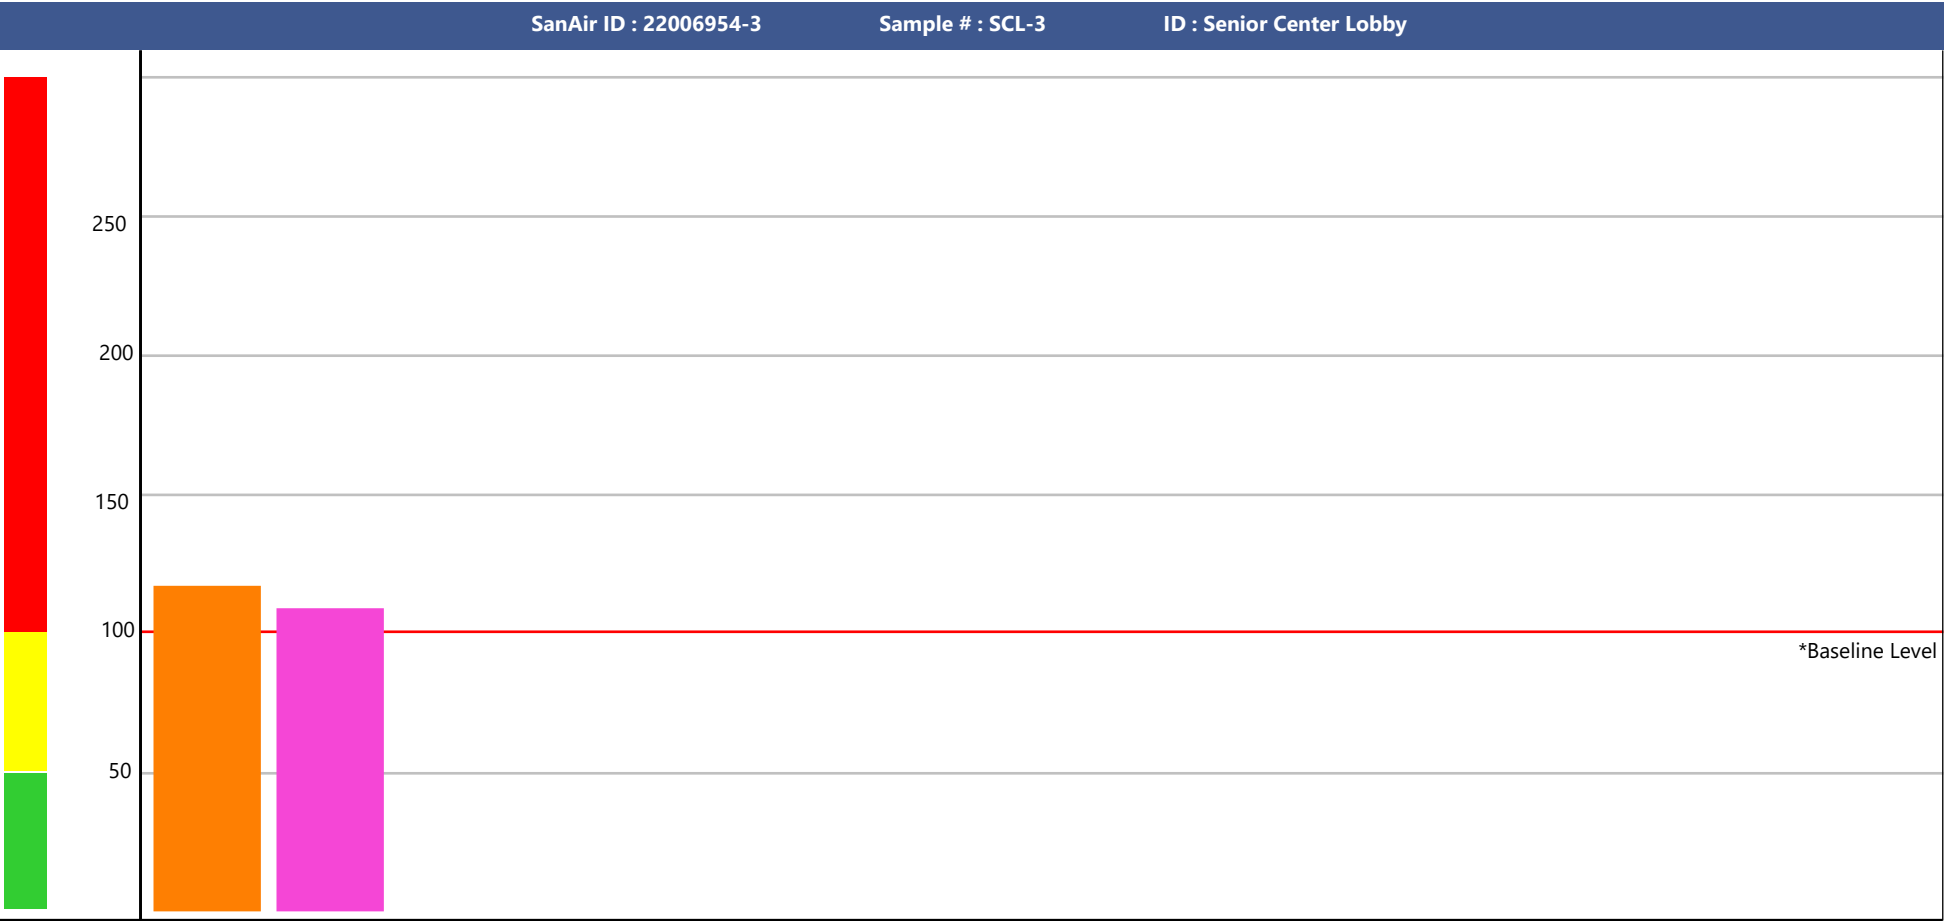
Air Cassette Analysis - Spores % of Outside Air

Count/m³ higher than Baseline	Aspergillus/Penicillium	Basidiospores
Count/m³ comparable to Baseline		
Within 50% of Baseline Count/m³

*The Baseline Level (100%) represents the average baseline sample counts. Counts above the baseline may indicate higher than expected levels of a given result.

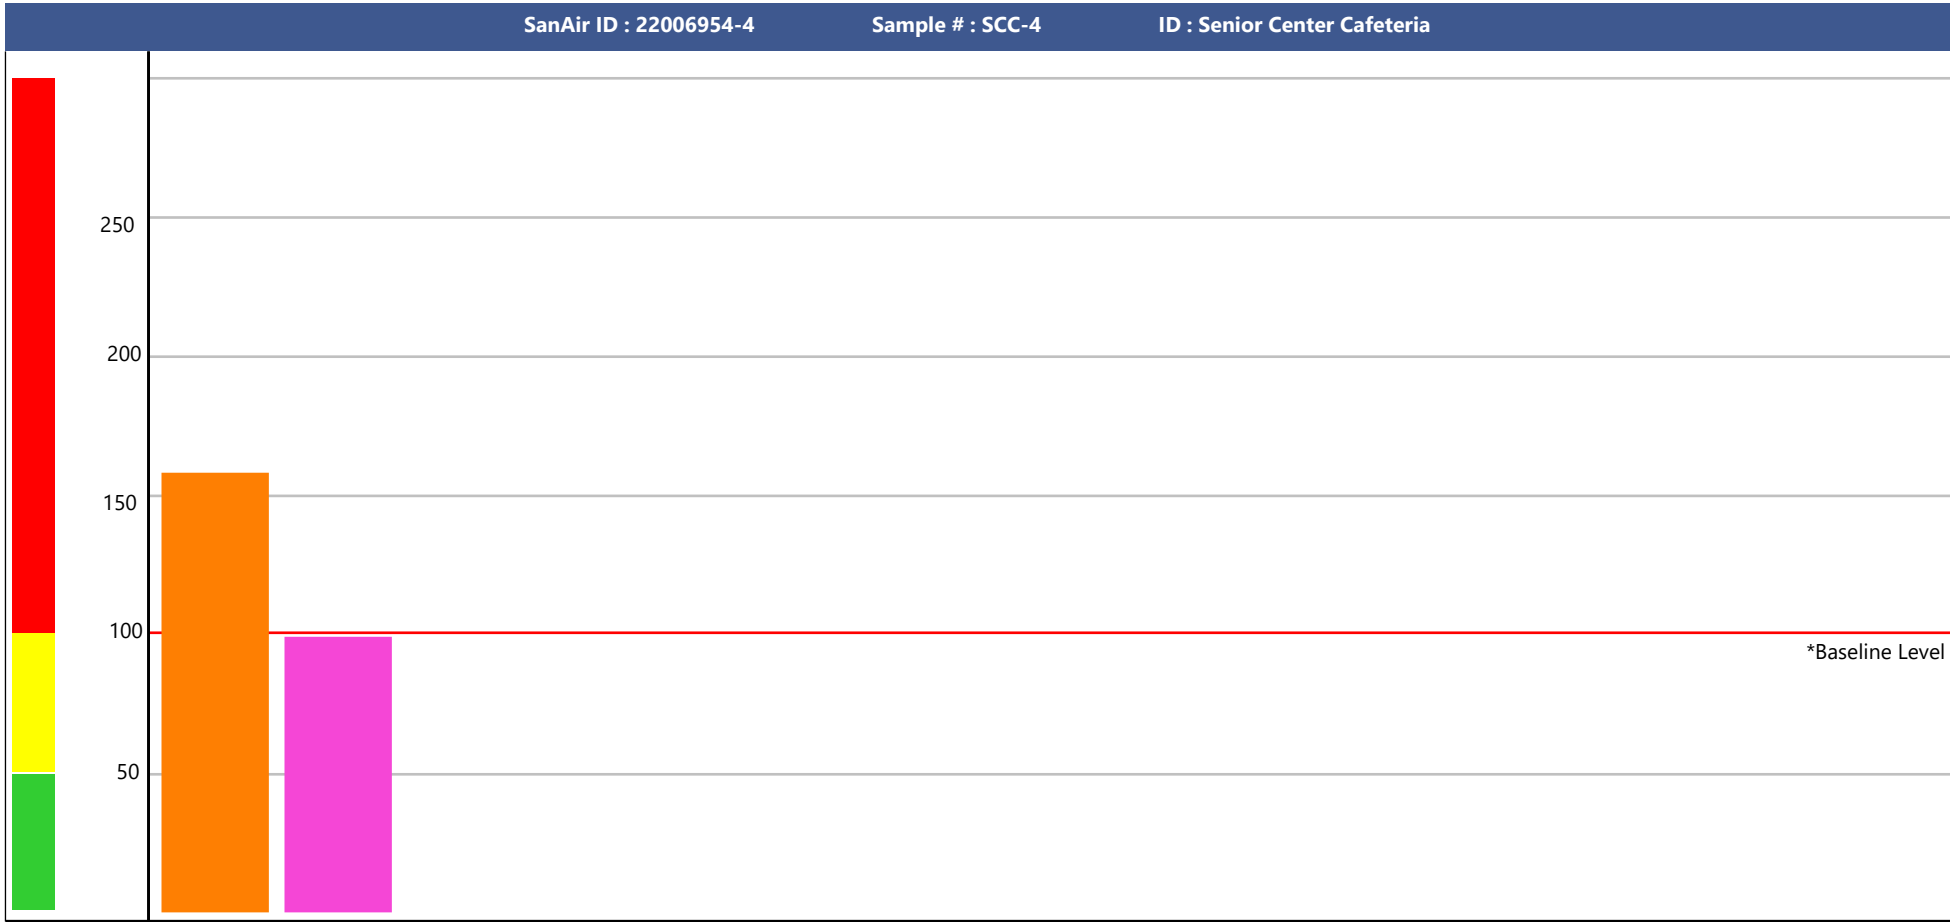
Air Cassette Analysis - Spores % of Outside Air

Count/m³ higher than Baseline	Aspergillus/Penicillium	Basidiospores
Count/m³ comparable to Baseline		
Within 50% of Baseline Count/m³

*The Baseline Level (100%) represents the average baseline sample counts. Counts above the baseline may indicate higher than expected levels of a given result.

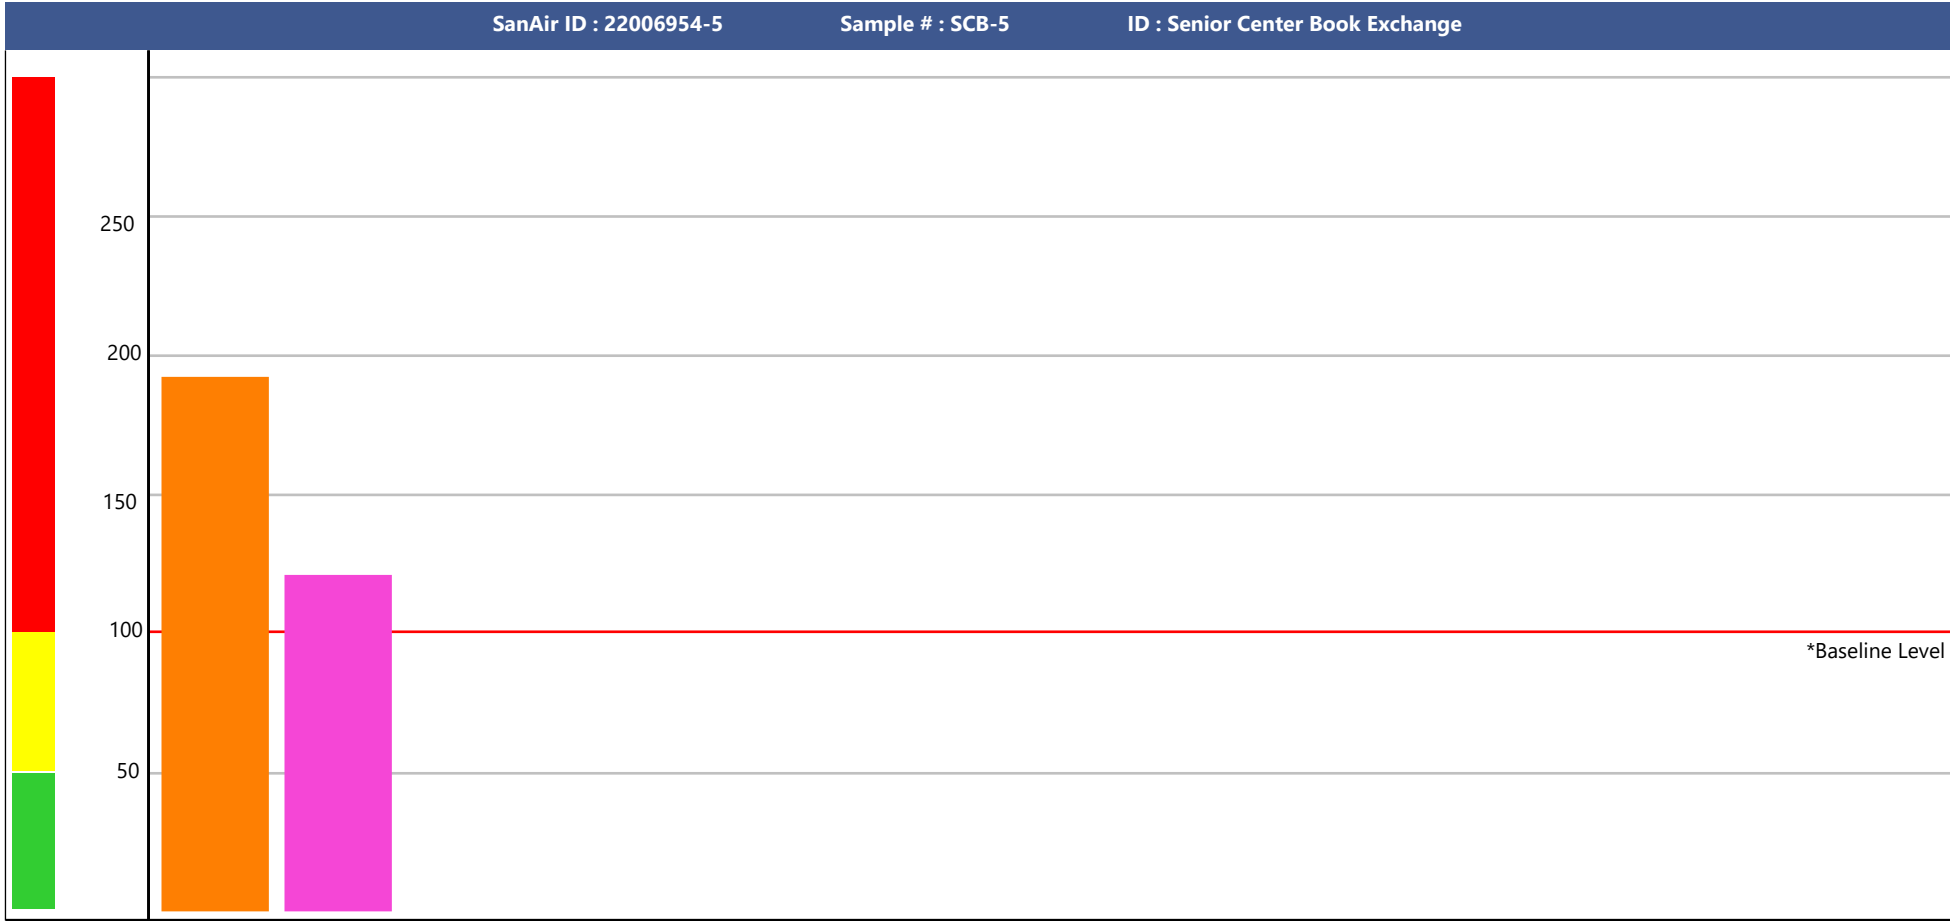
Air Cassette Analysis - Spores % of Outside Air

Count/m³ higher than Baseline	Aspergillus/Penicillium	Basidiospores
Count/m³ comparable to Baseline		
Within 50% of Baseline Count/m³

*The Baseline Level (100%) represents the average baseline sample counts. Counts above the baseline may indicate higher than expected levels of a given result.

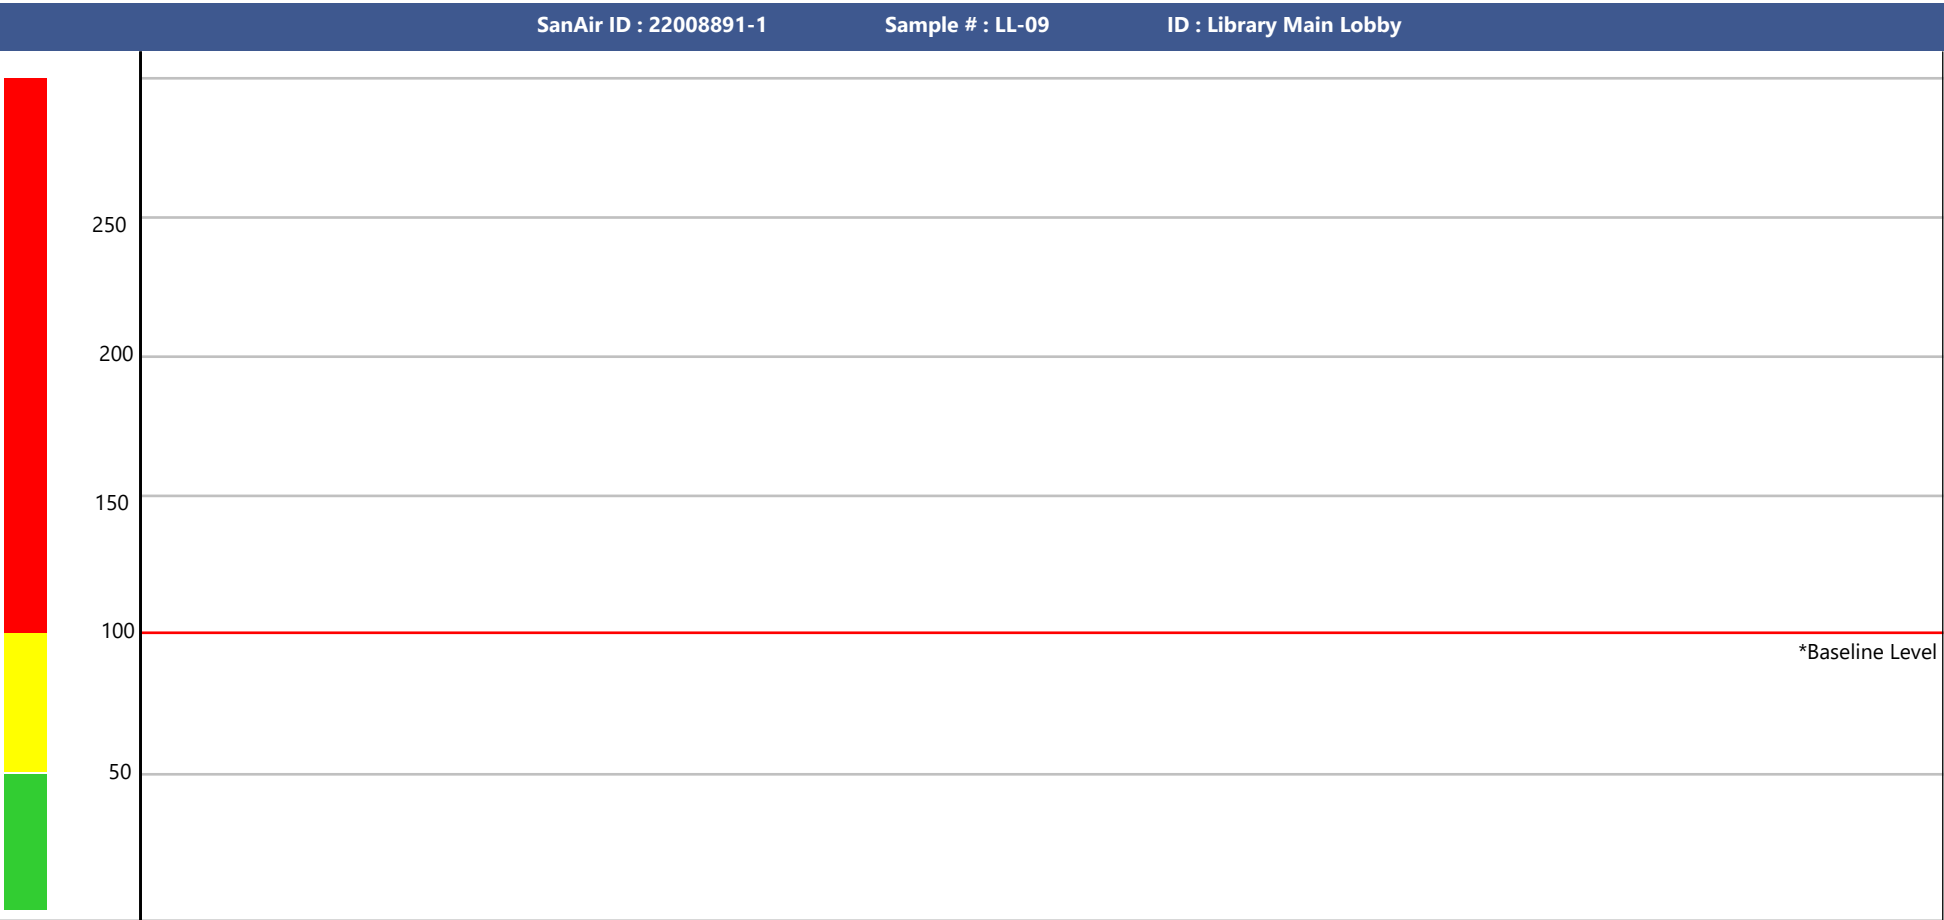
Air Cassette Analysis - Spores % of Outside Air

- Count/m³ higher than Baseline
- Count/m³ comparable to Baseline
- Within 50% of Baseline Count/m³

No organisms to graph. Normalized organism counts may not have exceeded the organism thresholds, or there were no organism counts for this sample. Please refer to the analysis report.

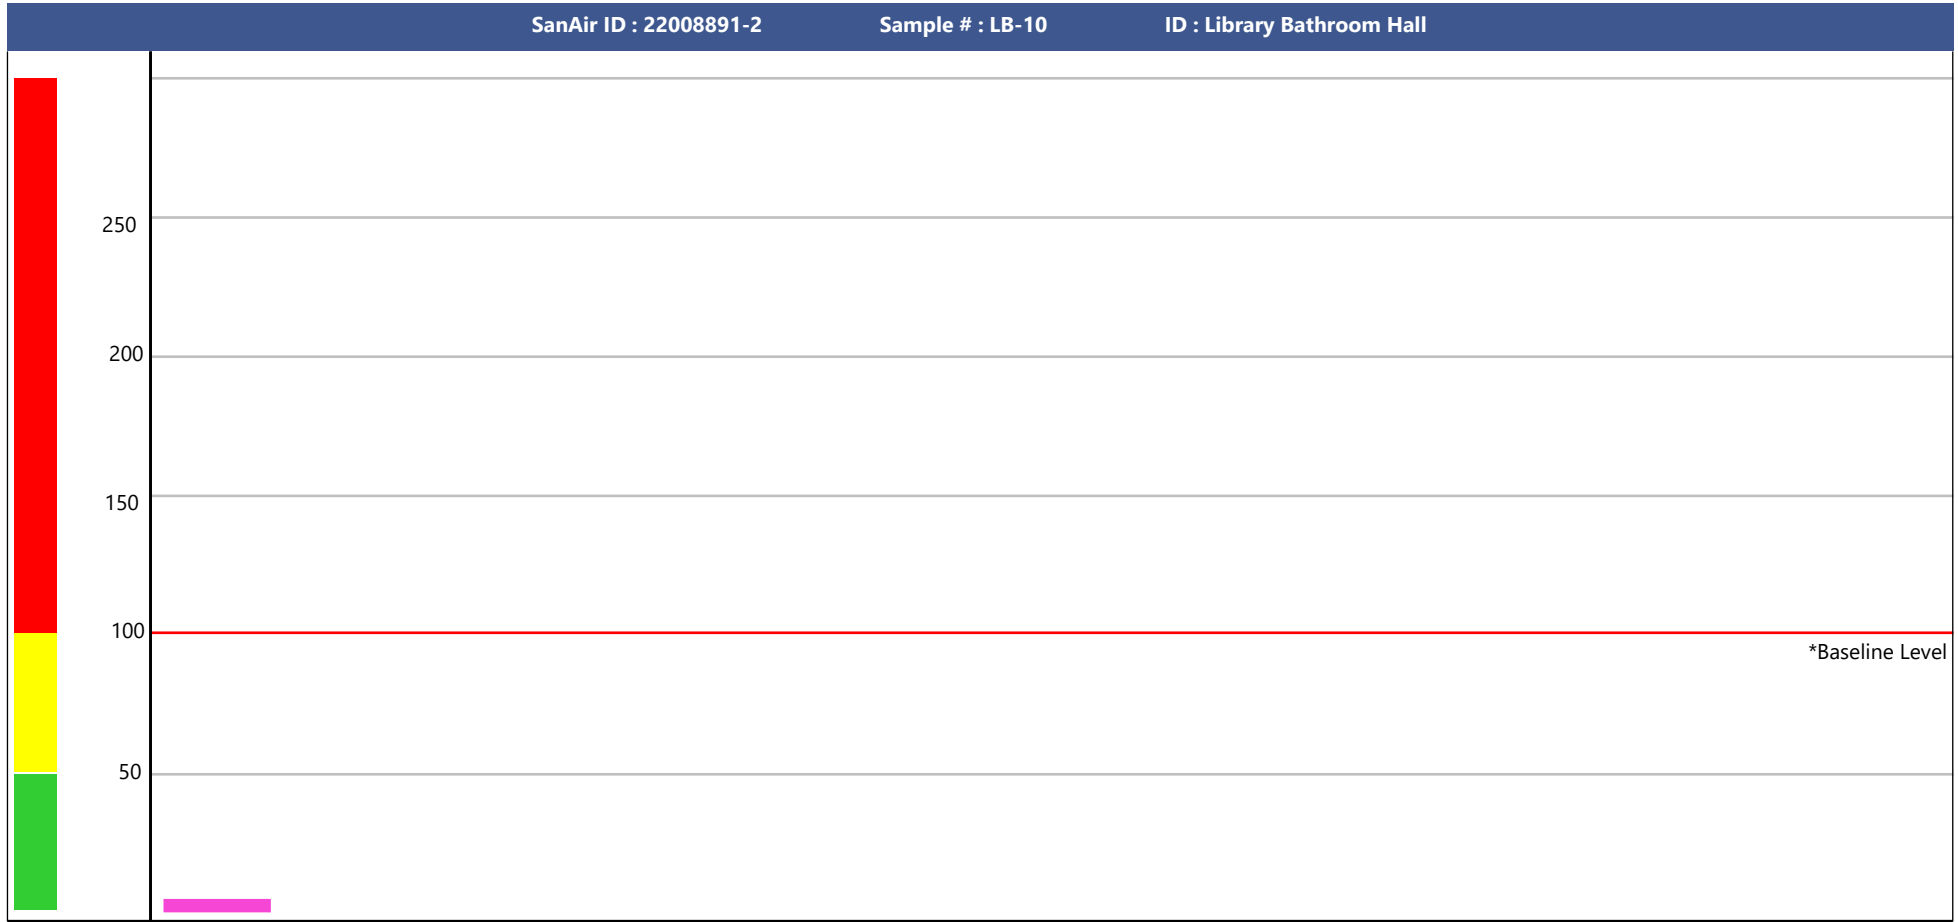
Air Cassette Analysis - Spores % of Outside Air

Count/m³ higher than Baseline	Basidiospores
Count/m³ comparable to Baseline	
Within 50% of Baseline Count/m³
